# ARMY AIR FORCES

## REPORT OF MAJOR ACCIDENT

| Section A—GENERAL INFORMATION | | | | | | | | | |
|---|---|---|---|---|---|---|---|---|---|
| Mississippi, Harrison, Biloxi, 37 miles south | | | | | Keesler Field, 38 miles south | | | | |
| <input type="checkbox"/> Yes <input checked="" type="checkbox"/> No | | | | | 11/27/44 | | 1716C | | |

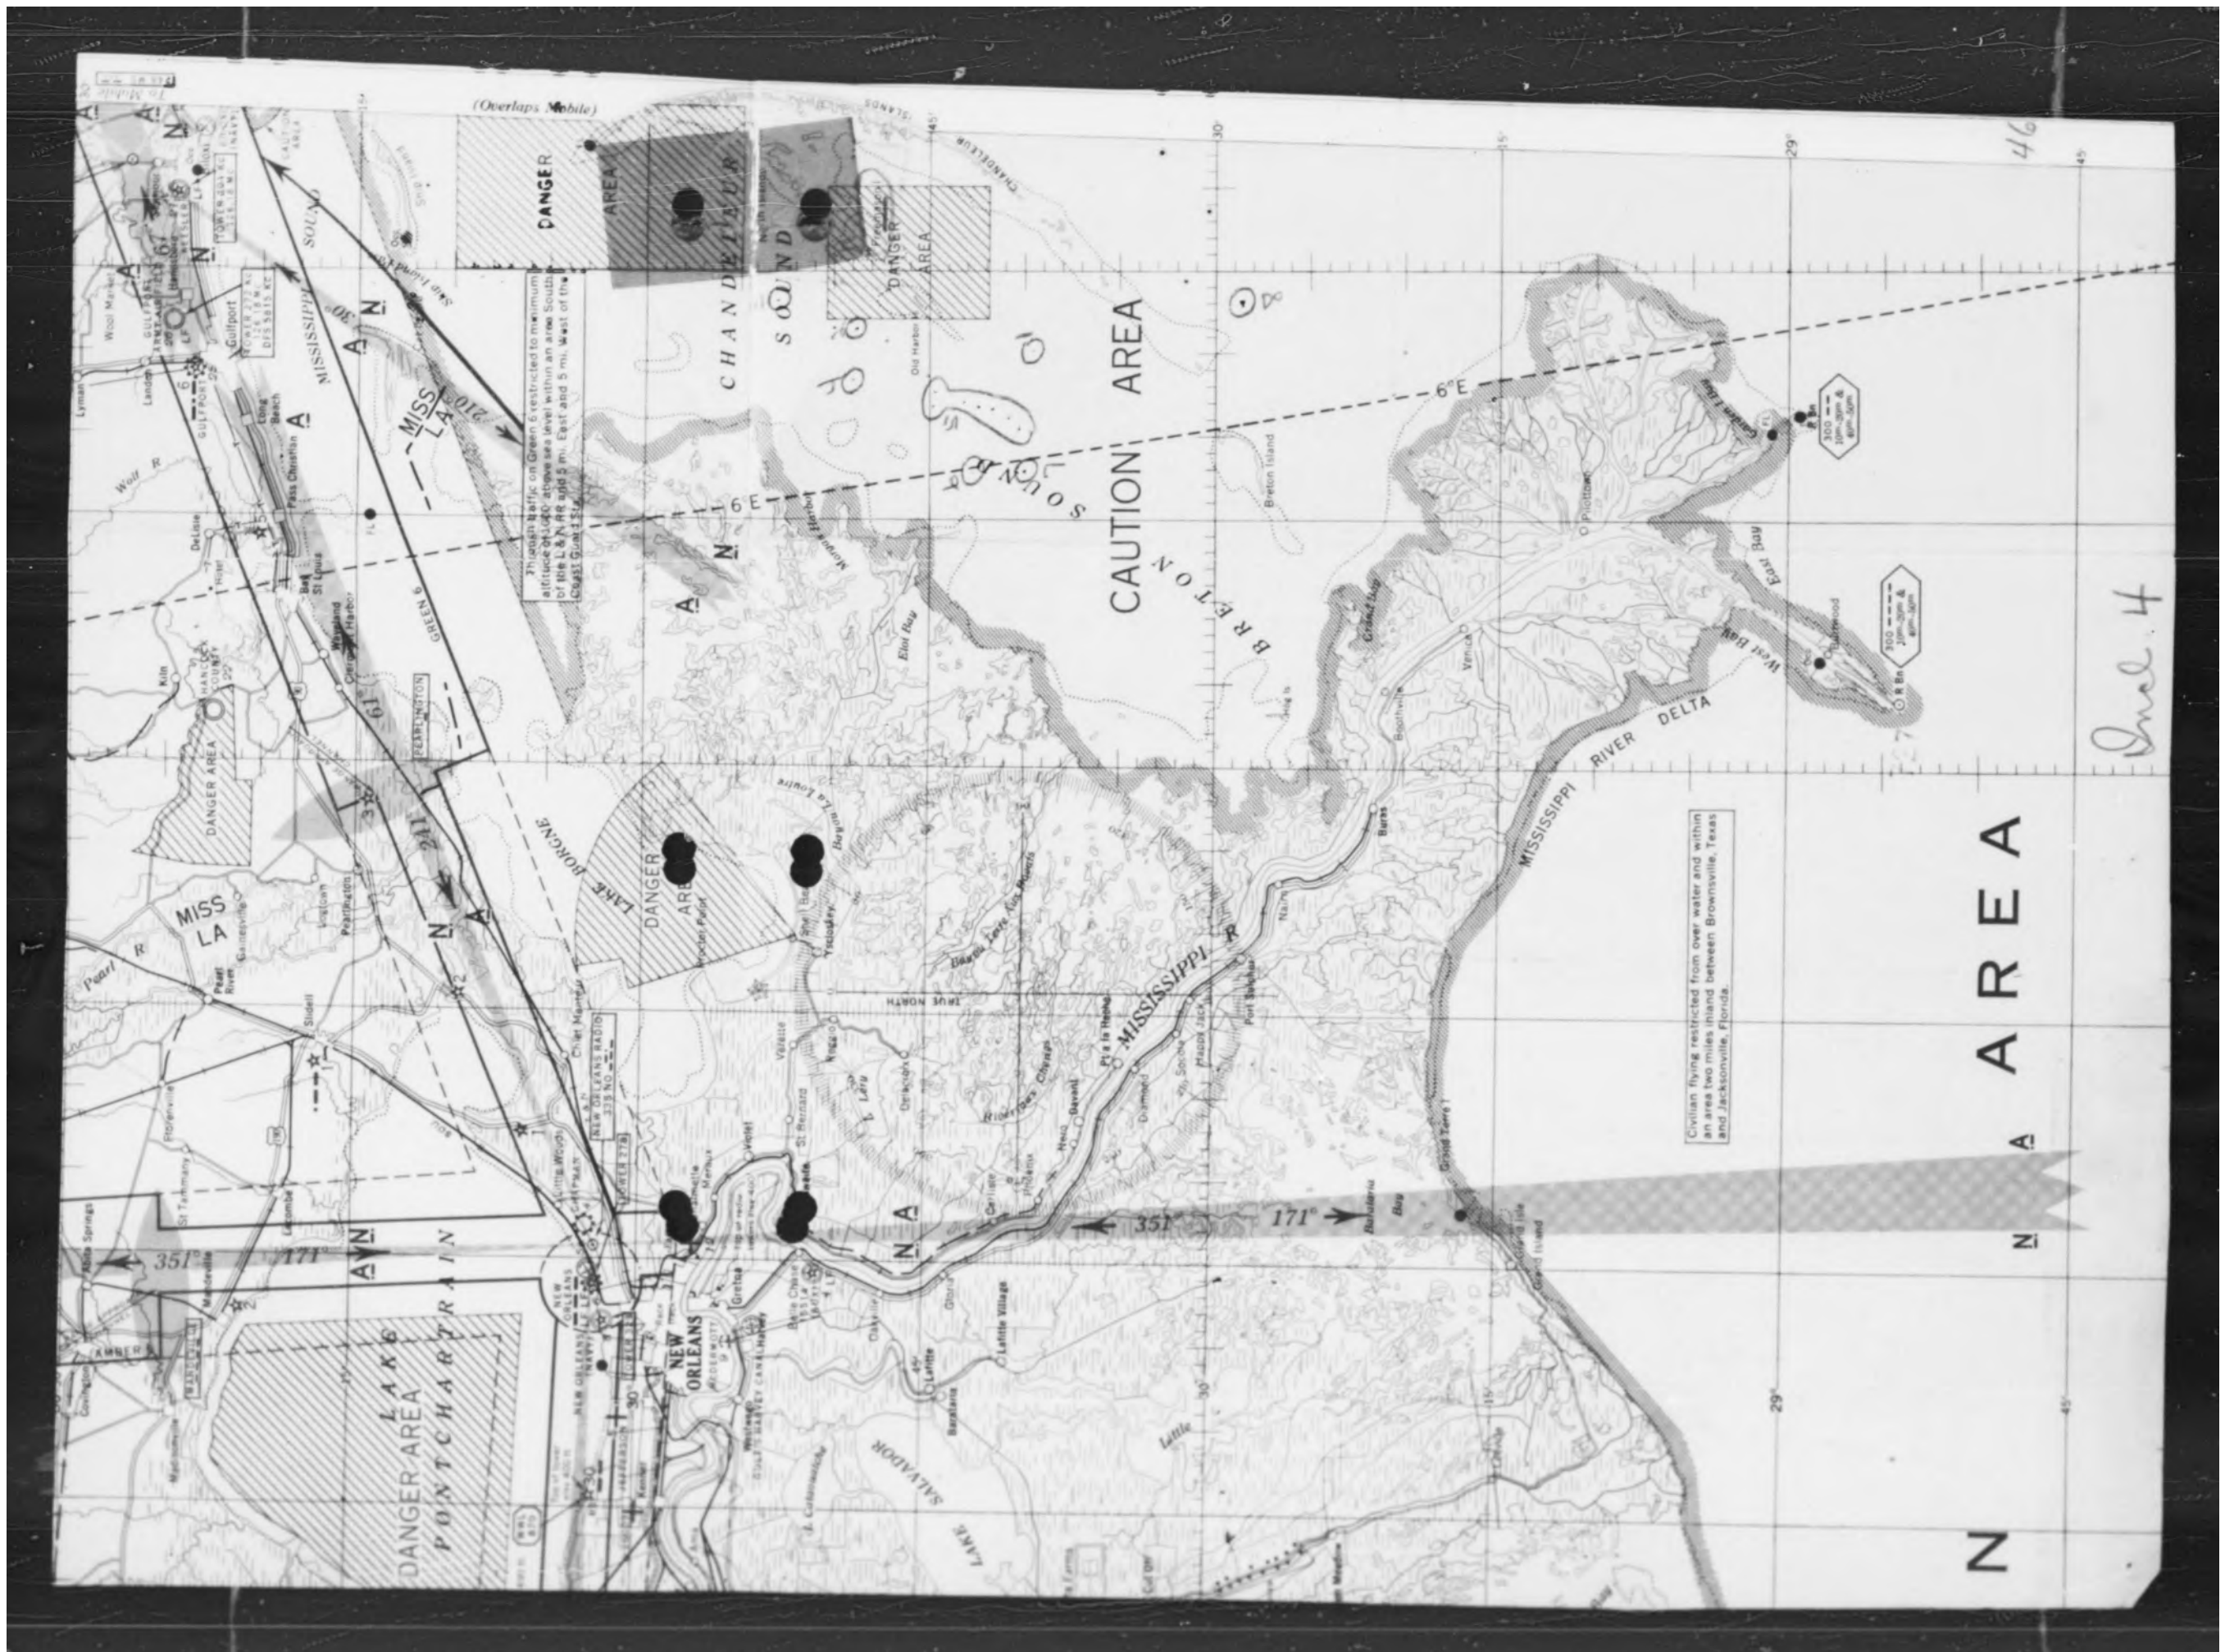
1. Approximate location where Pilot ~~Bumgar~~ stated he believed his crew bailed out at 1715C, 27 Nov. 1944.
2. Gulfport Rescue Boat P-728 was anchored in this location during the bombing and emergency but did not observe either phase, until advised by Gulfport radio at 1745C of the occurrence. Gulfport had been trying for 15 mins. to establish the contact but radio reception was very faulty.

3. Navigator on OA-10A which rescued Cpl. Johnston at 1800C estimated the position as 29° 53 mins. N. and 89° 03 mins. W.
4. Second OA-10 which assisted first OA-10 to locate airmen in the water re-estimated the position as 29° 50 mins. N. and 89° 07½ mins. W.

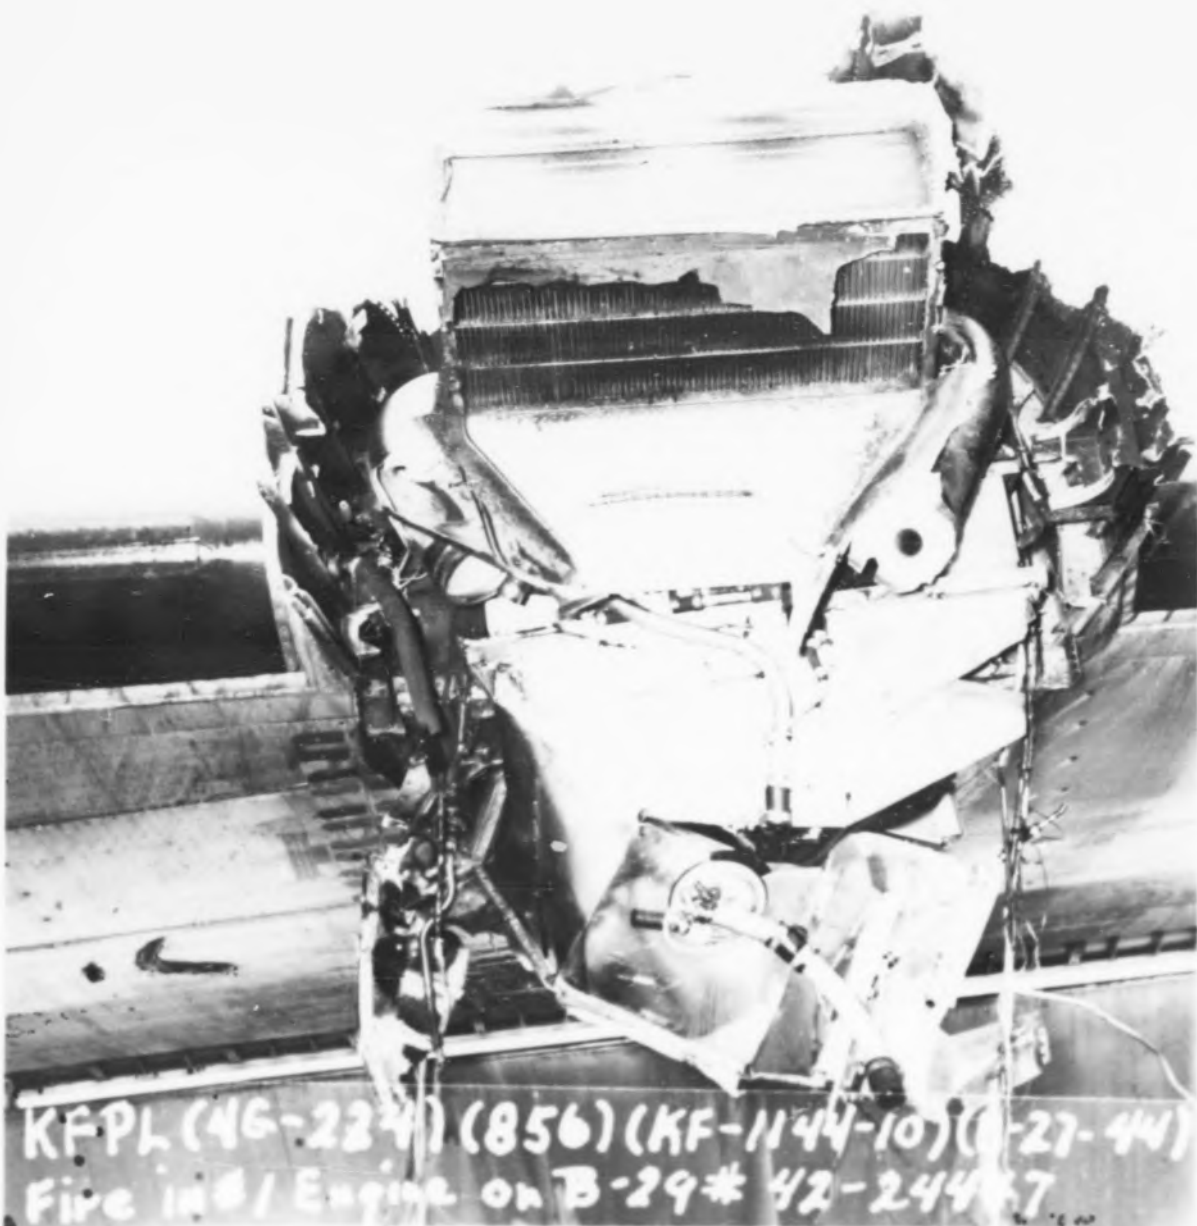
*lower front view  
#1 nacelle*

KFPL (46-224) (856) (KF-1144-10) (1-27-44)  
Fire in #1 Engine on B-29# 42-24487
